# Facade construction

## Bank Burgenland Eisenstadt

# New face for Bank Burgenland

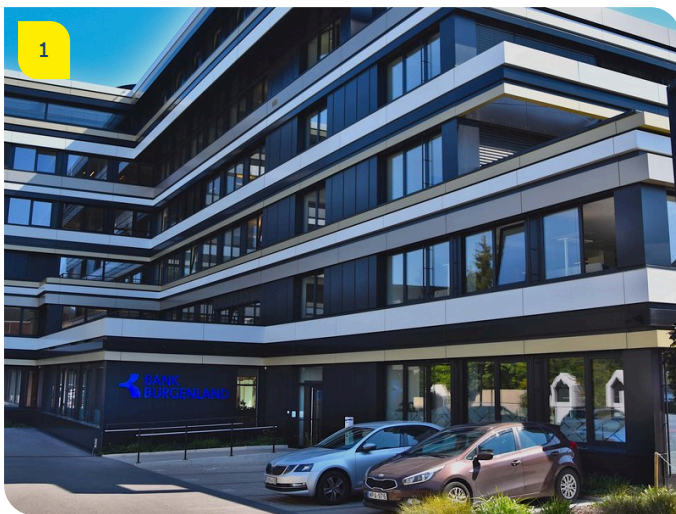
1

Modern façade as the centrepiece.

Thanks to the new façade of Bank Burgenland in Eisenstadt, the building impresses with its modern appearance and light-flooded interior.

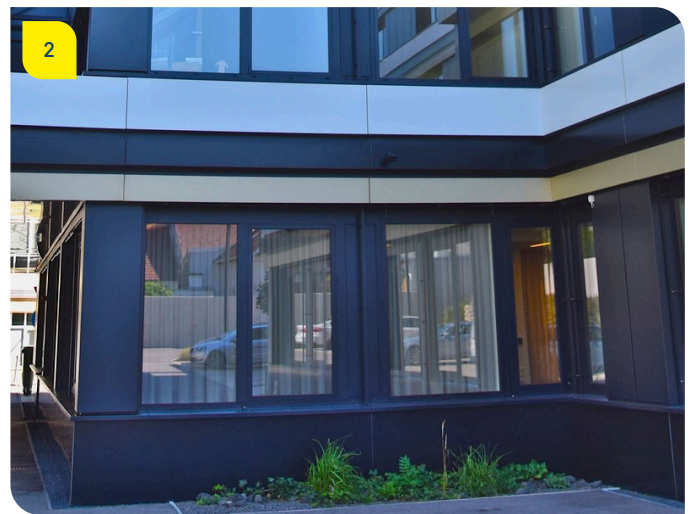
2

Extensive façade construction.

The mullion-transom façade with Alucobond louvre cladding gives the building its urban character.

A total of 2,000 m<sup>2</sup> of Alucobond louvre cladding, 1,700 m<sup>2</sup> of ribbon windows and 600 m<sup>2</sup> of mullion-transom façade were installed. In addition, 20 entrance elements and E130 interior doors were installed.
