# Meidling Emergency Hospital Helipad

| Type | Steel construction |
| Principal | Austrian General Accident Insurance Institution AUVA |

# Helipad for the Meidling Emergency Hospital.

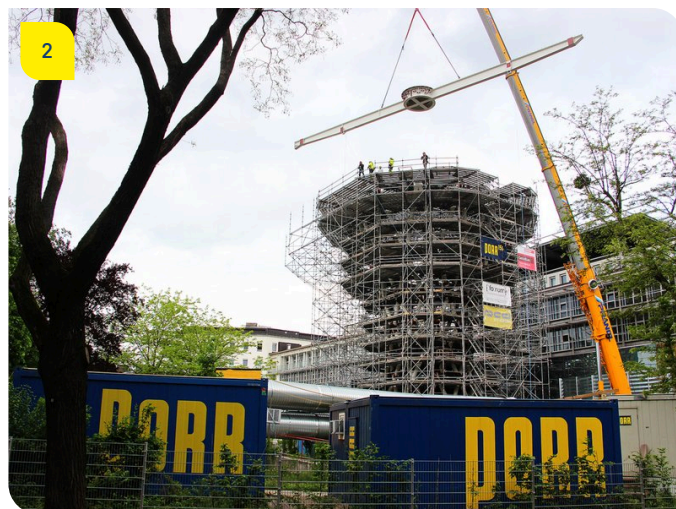
2

Leading role

The rendering by FORUM - Architekten + Ingenieure ZT GmbH already showed the double helix to be built from steel pipes.

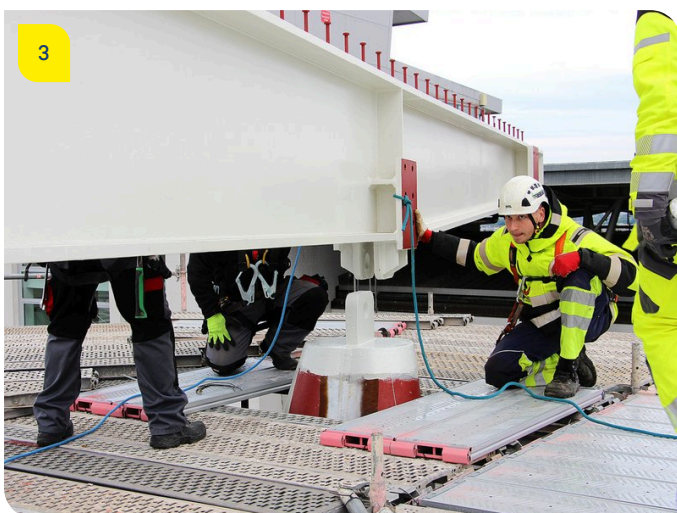
3

Leading role

The spectacular lifting of the 28m long platform beam with the central ring construction.

The radially running girders were connected to a central ring. A splice joint allowed both the bending moments to be transferred and the geometric tolerances to be compensated for by utilising the existing hole tolerance. The radial and tangential rows of beams were connected by means of head plates, and the safety net was attached to the ring beam. The seats of the connecting bridge are designed in such a way that independent movement to the existing structure is possible even in the event of an earthquake. Finally, the entire double helix was given a fire protection coating. At the outermost edge of the platform, we implemented lighting effects that set off the structure perfectly.

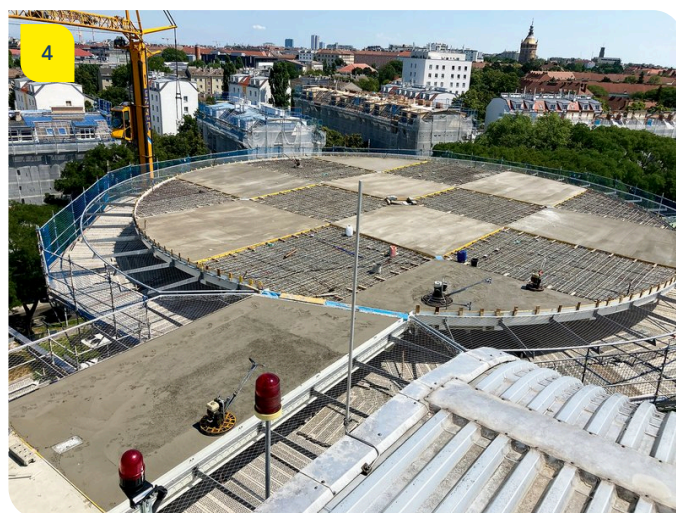
4

Checkerboard-like pouring of the concrete.

Heating mats, drainage gullies, beacons, temperature sensors and lightning protection devices were integrated into the secondary concrete.

A bituminous seal is applied over the primary concrete. This is where residual water that cannot be diverted on the top level is discharged. A level with heating mats is arranged in the secondary concrete. This heating level ensures that no snow remains on the platform and that the surface does not ice up. In the secondary concrete there are also drainage gullies, beacons, temperature sensors and lightning protection devices.

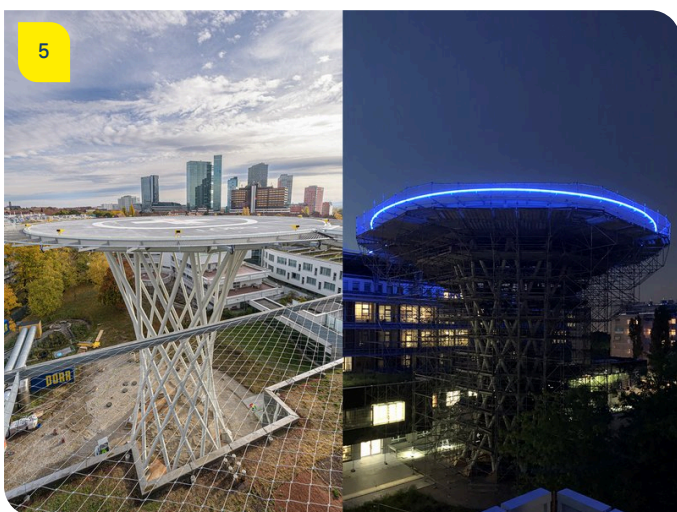
5

Ready for use both day and night.

The new helipad has been in use since autumn 2021.
